An Introduction to Bearing Failure

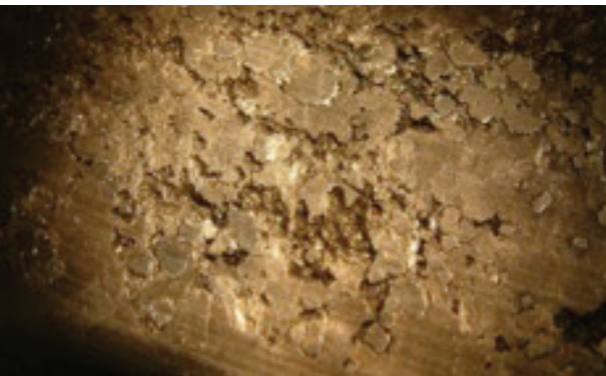
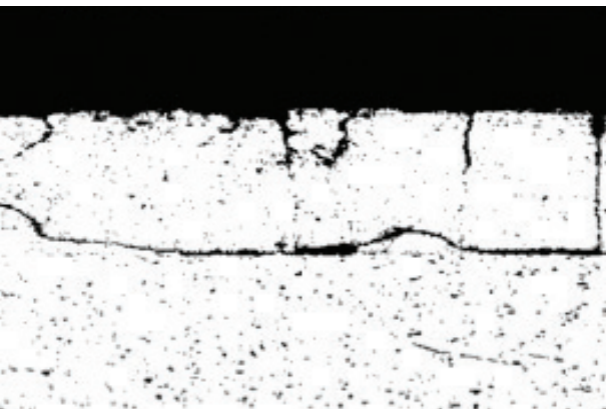
Fatigue

- Hairline cracks in the whitemetal surface around the area of applied load
- Surface cracks cannot propagate into the harder backing material so turn sideways along bond line leading to sections of whitemetal detaching

- Excessive dynamic loads
- Overheating causing a reduction in fatigue strength
- Misalignment
- High Levels of vibration
- Poor localised repairs

- Eliminate causes of dynamic load
- Review bearing alignment
- Increase load carrying capacity
- Consider bearing materials with higher resistance to dynamic loads

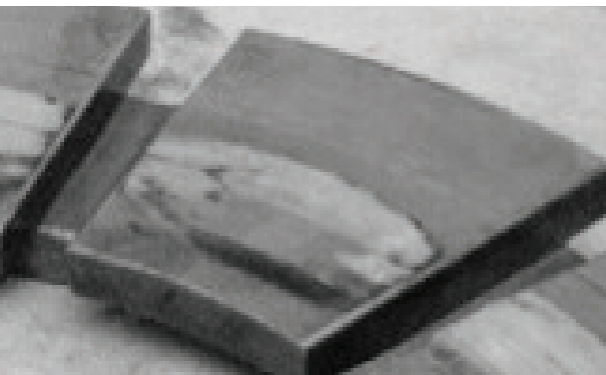
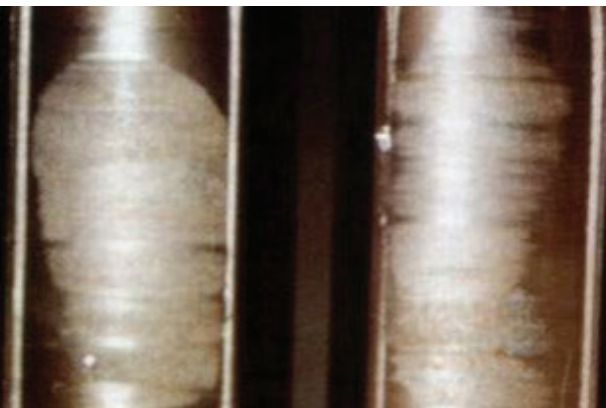
Loss of Oil Film

- Polished band across some or all of surface
- No evidence of overload on pivots or housing
- No excessive wiping of whitemetal

- Insufficient lubricant supply to bearing
- Inappropriate lubricant type (viscosity, temperature)
- Deflect or distortion of journal pads or collars
- Excessive loads during start up

- Check and modify lubricant supply and type
- Check collars and pads for flatness and squareness
- Check for possible overloading

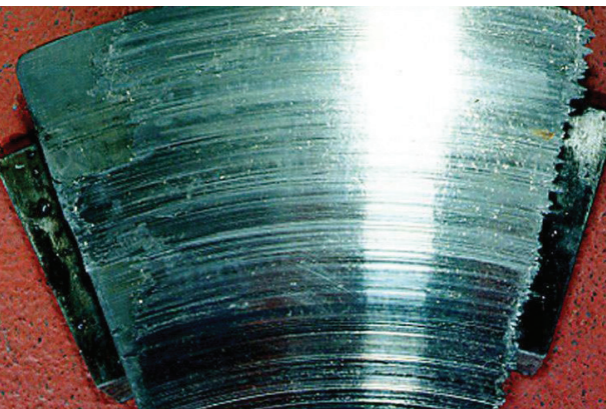
Scoring / Erosion

- Score marks in surface following the direction of motion
- Erosion wear of surface roughening / dulling of the surface

- Scoring due to contaminant particles larger than the minimum film thickness embedded into the whitemetal layer
- Erosion caused by large quantities of small particles in the lubricant smaller than the oil film thickness typically located near to oil entry point
- High velocity lubricant flow
- Atmospheric contamination via seals or breathers
- Could lead to complete failure due to reduced oil films and a reduction in the load carrying capacity

- Repair damaged running surfaces
- Clean lubricant and flush surfaces before restarting
- Replace and check correct filtration is being used

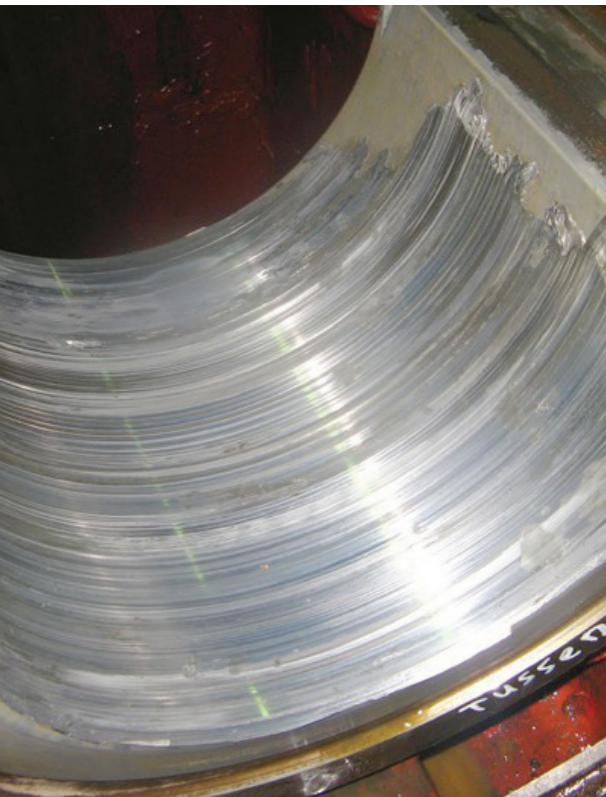
Overload / Wiping

- Circumferential movement (wiping) of whitemetal
- Heavy scoring
- Pivots show flattening or indentation
- Re-solidification of whitemetal deposited in oil grooves

- Excessive load above design duties
- Failure of the Hydrodynamic oil film
- Oil inlet temperature too high
- Incorrect oil grade used
- Loading applied into oil grooves
- Inadequate clearances

- Reassess bearing design inputs and operating loads
- Reduce load on bearings
- Increase load carrying capacity
- Consider higher load bearing design such as off-set pivot

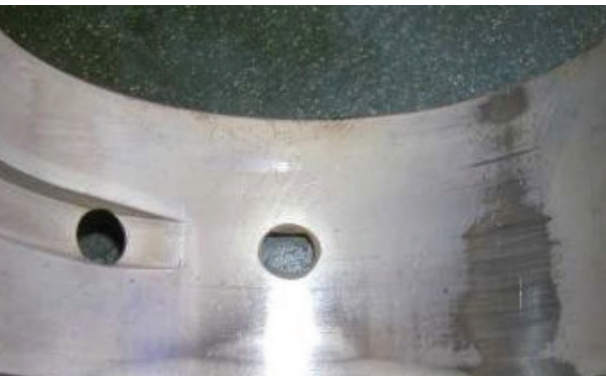
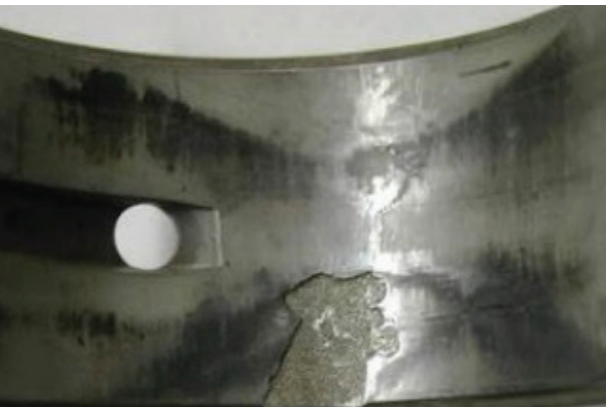
- Polishing pattern on one side or localized area of babbitt surface
- Localised severe wear
- High localised temperature
- Fatigue failure in diagonally opposed areas in top and bottom halves

- Load concentration on one area of bearing. Due to geometry misalignment
- Axial mismatch between journal and bearing centre lines
- Misalignment of bearing housing or shaft
- Journal deflection under load

- Re-align bearings
- Switch to a more misalignment tolerant design such as, tilting pad, equalised thrust or self aligning bearings

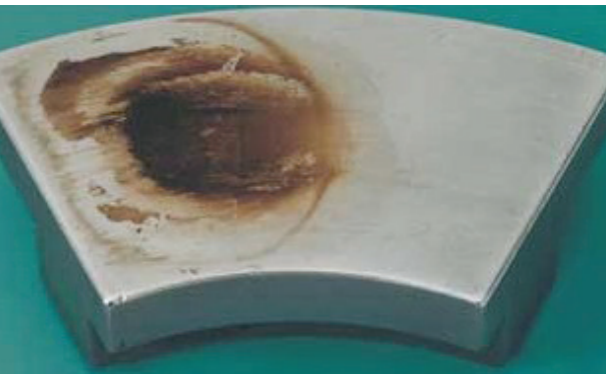
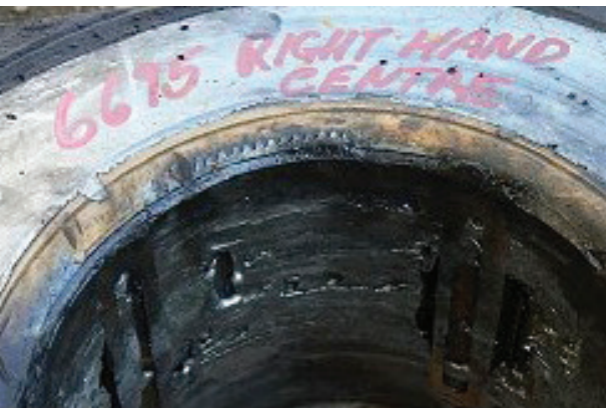
Overheating

- Oil varnish / lacquer build up in hot areas
- Possible local cracking and movement of whitemetal
- Discolouration of steel

- Over speed / excessive load
- Loss of oil film due to varnish build up
- Oil inlet temperature too high
- Insufficient bearing clearance
- Failure of cooling / insulation mechanism

- Reduce oil inlet temperature
- Review cooling / insulation mechanism
- Change to a more heat stable lubricant
- Increase oil flow
- Increase load carrying capacity

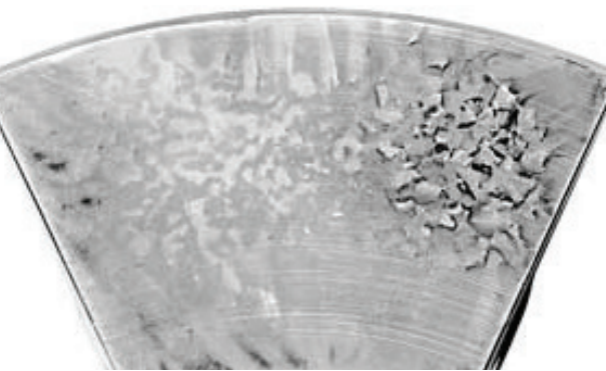
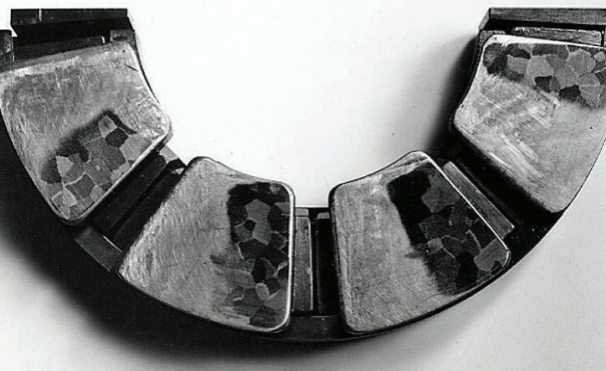
Thermal Ratcheting

- Marble type relief pattern on whitemetal surface. Typically more noticeable on trailing (hotter) part of bearing
- Crack formation between grains

- Repeated thermal cycling triggering anisotropic thermal expansion of tin crystals within the whitemetal
- Uneven thermal expansion of tin based whitemetal
- Switching from lead to tin based whitemetal

- Review alloy composition to reduce grain size
- Where possible minimize thermal cycling

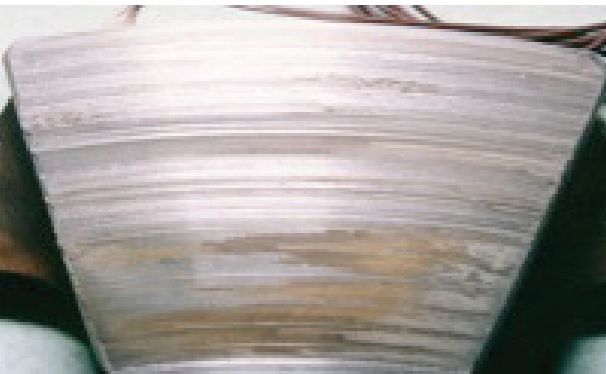
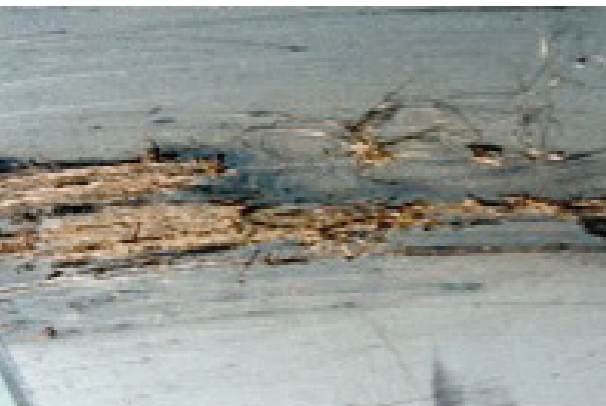
Wire Wool Damage

- Very heavy scoring of the whitemetal surface in short time period
- Hard scabs of material embedded into the whitemetal surface

- Failure initiated by small particles of dirt embedding into the bearing surface
- Shaft material containing chromium or manganese in the region of 2% - 14% are incompatible with whitemetal
- Long term exposure to water in oil can lead to scab formation (tin oxide)
- Most aluminium bronzes are incompatible with whitemetal

- Change journal or collar material to mild steel
- Hard chrome surface in contact with whitemetal

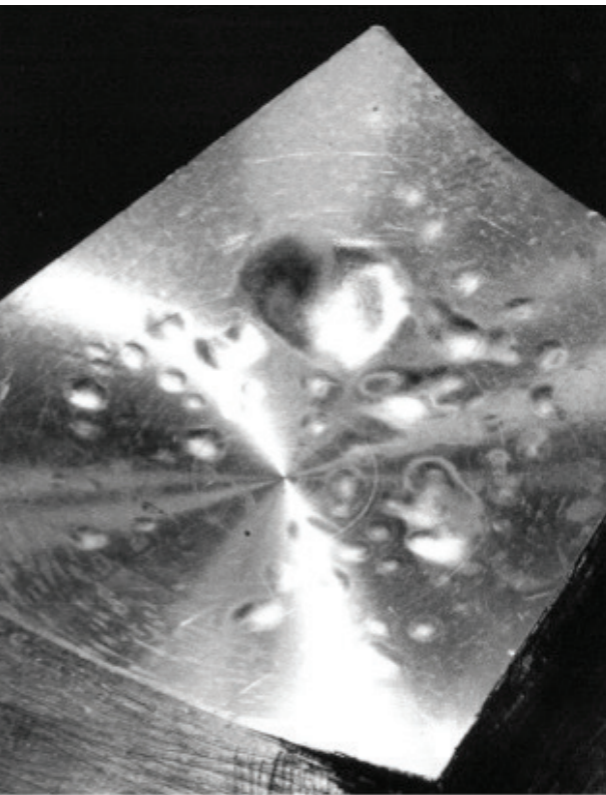
Hydrogen Blisters

- Blister under the whitemetal layer
- Can become visible following long periods of storage or operation

- Hydrogen within the mild steel diffuses out to the bond line then becomes trapped, breaking the mechanical bond

- Degas steel prior to use through thermal or vacuum treatment
- Repair blistered surfaces
- Avoid hydrogen sources during manufacture

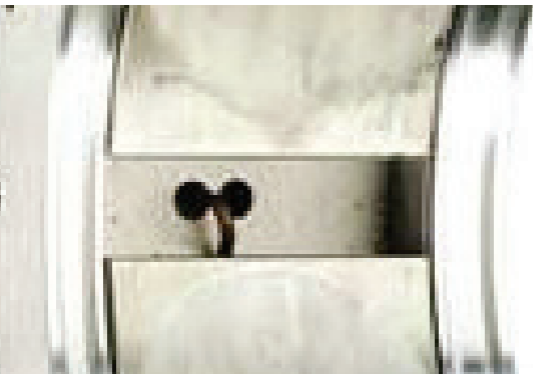
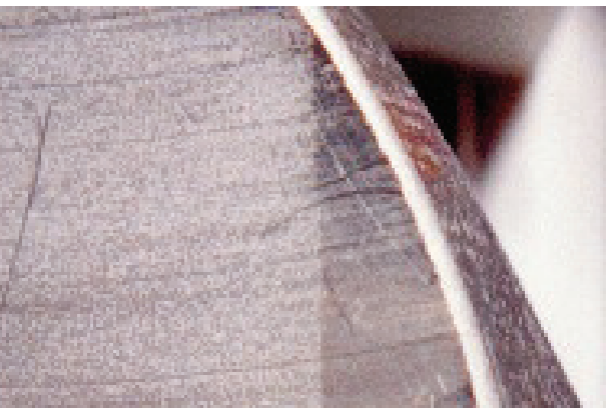
Electrical Pitting

- Numerous uniform pits concentrated in discrete areas
- Frosted appearance in pitted area
- Pitting concentrated to areas with lowest oil film thickness (least insulation)
- Damage will be present on both the bearing and shaft

- Poor insulation allowing electrostatic arcing between the shaft and bearing
- Electromagnetic currents from rotating shaft
- Water in oil or film cavitation disrupts insulating effect of the oil

- Grounding of shaft currents
- Insulation of bearings
- Replace lubrication oil and flush housing to remove water content

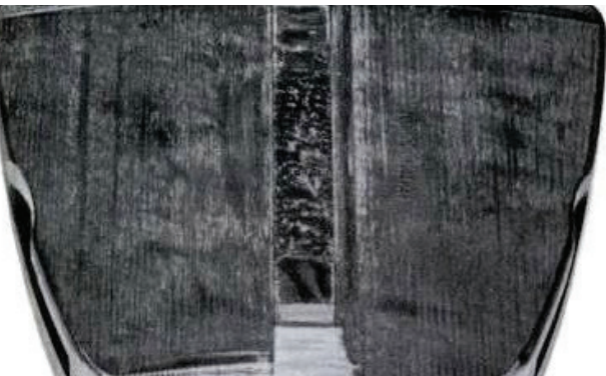
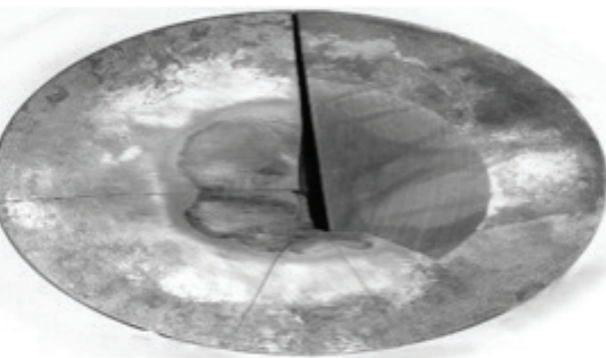
Pivot Damage / Fretting

- Wear and erosion of contact surfaces
- Discolouration around contact area
- Cracks or fractures to highly loaded pivot point
- Flattened pivot area

- Fretting caused by vibration of machinery
- Overload of pads
- Insufficient pivot contact area to support load

- Repair existing pivots
- Reduce the load on the pivots or increase the pivot radius to support higher loads
- Minimise external vibrations
