# An Introduction to Bearing Failure

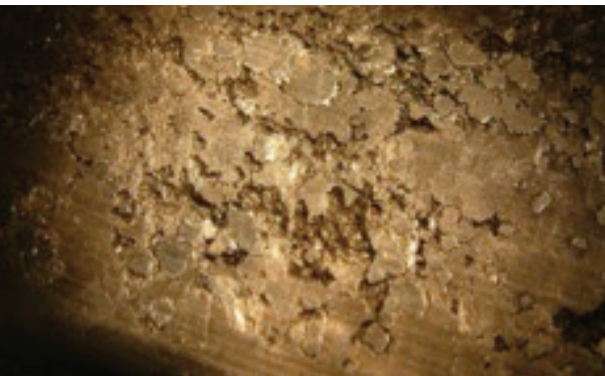
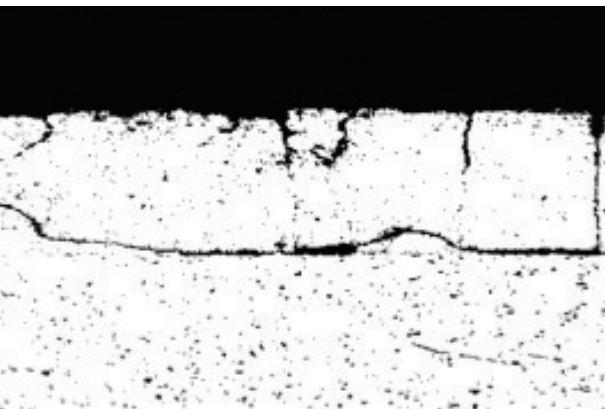
# Fatigue

- Hairline cracks in the whitemetal surface around the area of applied load
- Surface cracks cannot propagate into the harder backing material so turn sideways along bond line leading to sections of whitemetal detaching

- Excessive dynamic loads
- Overheating causing a reduction in fatigue strength
- Misalignment
- High Levels of vibration
- Poor localised repairs

- Eliminate causes of dynamic load
- Review bearing alignment
- Increase load carrying capacity
- Consider bearing materials with higher resistance to dynamic loads

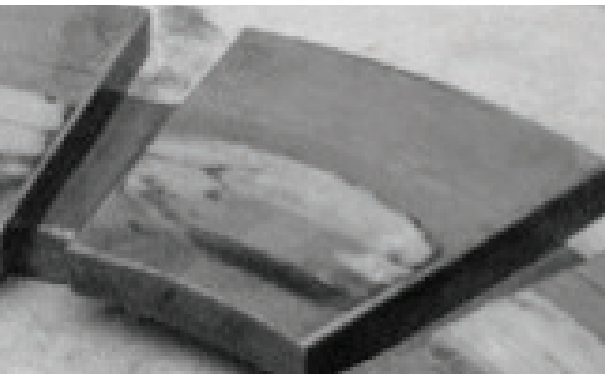
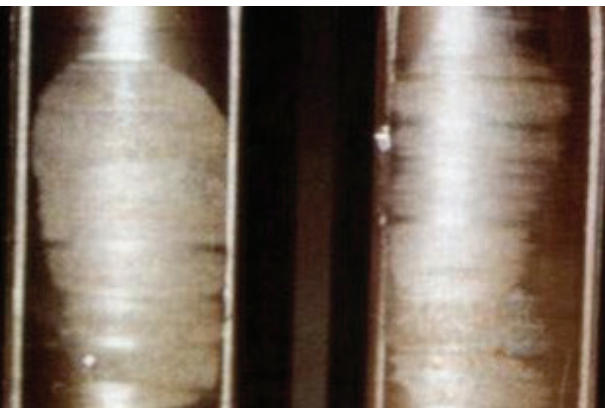
# Loss of Oil Film

- Polished band across some or all of surface
- No evidence of overload on pivots or housing
- No excessive wiping of white metal

- Insufficient lubricant supply to bearing
- Inappropriate lubricant type (viscosity, temperature)
- Deflect or distortion of journal pads or collars
- Excessive loads during start up

- Check and modify lubricant supply and type
- Check collars and pads for flatness and squareness
- Check for possible overloading

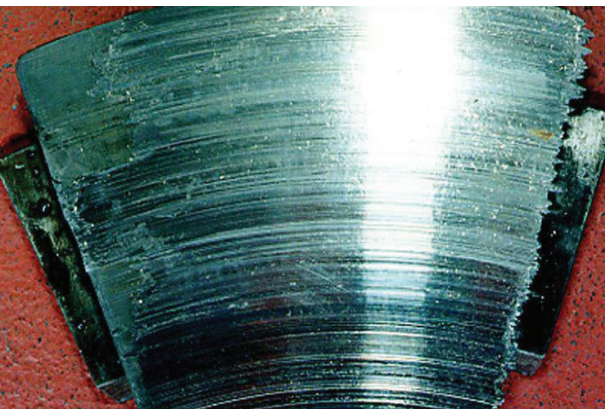
# Scoring / Erosion

- Score marks in surface following the direction of motion
- Erosion wear of surface roughening / dulling of the surface

- Scoring due to contaminant particles larger than the minimum film thickness embedded into the whitemetal layer
- Erosion caused by large quantities of small particles in the lubricant smaller than the oil film thickness typically located near to oil entry point
- High velocity lubricant flow
- Atmospheric contamination via seals or breathers
- Could lead to complete failure due to reduced oil films and a reduction in the load carrying capacity

- Repair damaged running surfaces
- Clean lubricant and flush surfaces before restarting
- Replace and check correct filtration is being used

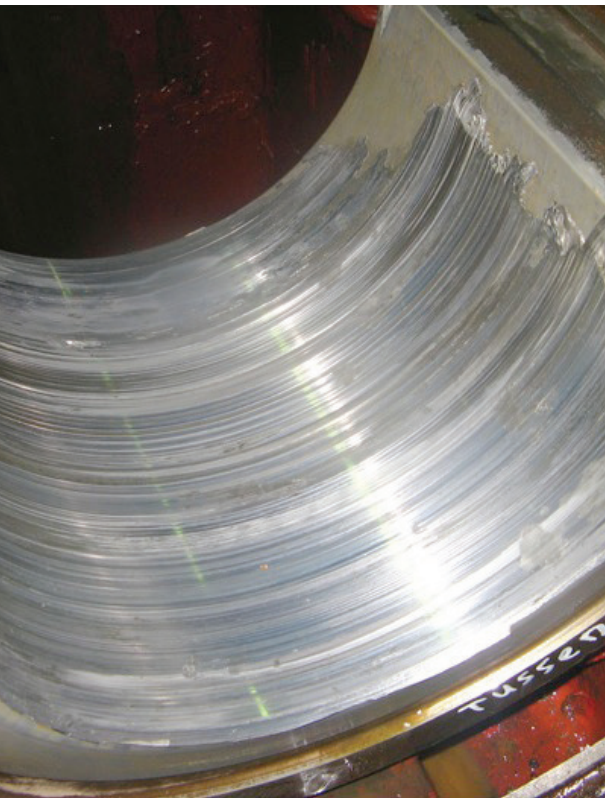
# Overload / Wiping

- Circumferential movement (wiping) of whitemetal
- Heavy scoring
- Pivots show flattening or indentation
- Re-solidification of whitemetal deposited in oil grooves

- Excessive load above design duties
- Failure of the Hydrodynamic oil film
- Oil inlet temperature too high
- Incorrect oil grade used
- Loading applied into oil grooves
- Inadequate clearances

- Reassess bearing design inputs and operating loads
- Reduce load on bearings
- Increase load carrying capacity
- Consider higher load bearing design such as off-set pivot

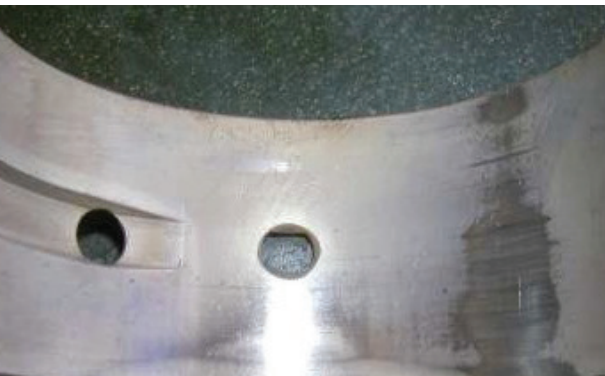
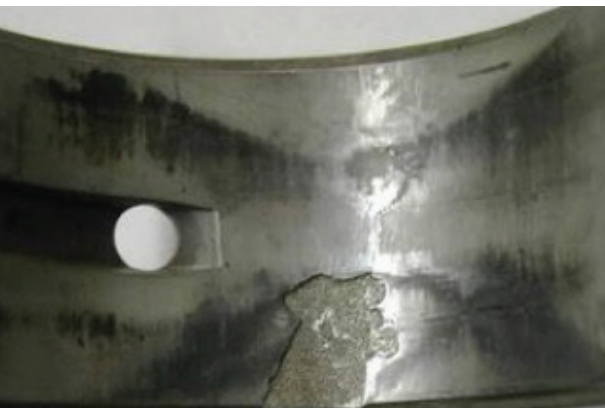
# Misalignment

- Polishing pattern on one side or localized area of babbitt surface
- Localised severe wear
- High localised temperature
- Fatigue failure in diagonally opposed areas in top and bottom halves

- Load concentration on one area of bearing. Due to geometry misalignment
- Axial mismatch between journal and bearing centre lines
- Misalignment of bearing housing or shaft
- Journal deflection under load

- Re-align bearings
- Switch to a more misalignment tolerant design such as, tilting pad, equalised thrust or self aligning bearings

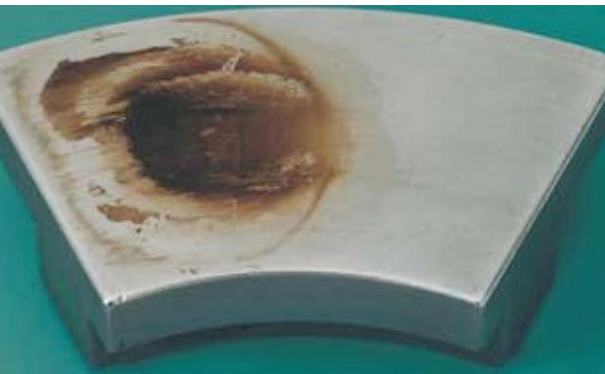
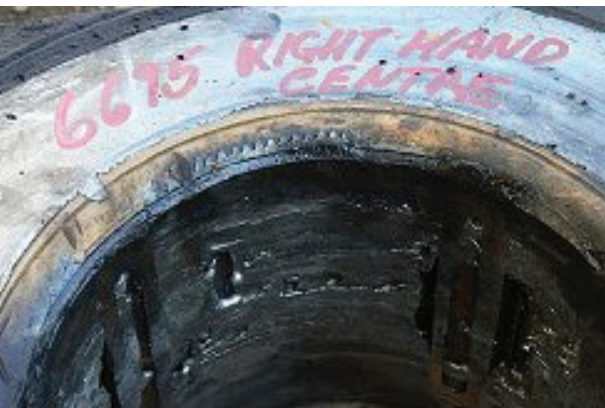
# Overheating

- Oil varnish / lacquer build up in hot areas
- Possible local cracking and movement of whitemetal
- Discolouration of steel

- Over speed / excessive load
- Loss of oil film due to varnish build up
- Oil inlet temperature too high
- Insufficient bearing clearance
- Failure of cooling / insulation mechanism

- Reduce oil inlet temperature
- Review cooling / insulation mechanism
- Change to a more heat stable lubricant
- Increase oil flow
- Increase load carrying capacity

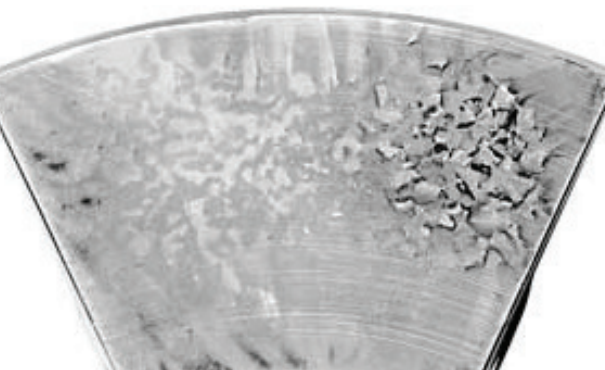
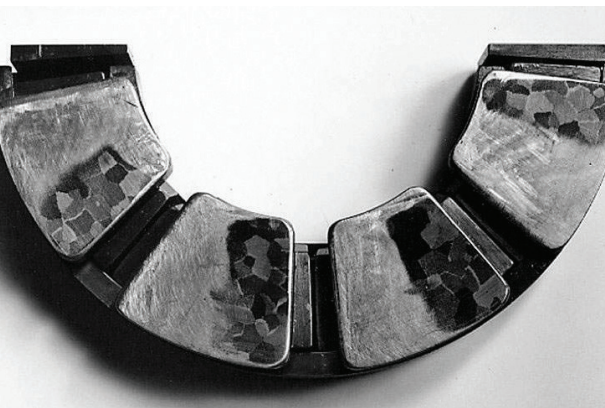
# Thermal Ratcheting

- Marble type relief pattern on whitemetal surface. Typically more noticeable on trailing (hotter) part of bearing
- Crack formation between grains

- Repeated thermal cycling triggering anisotropic thermal expansion of tin crystals within the whitemetal
- Uneven thermal expansion of tin based whitemetal
- Switching from lead to tin based whitemetal

- Review alloy composition to reduce grain size
- Where possible minimize thermal cycling

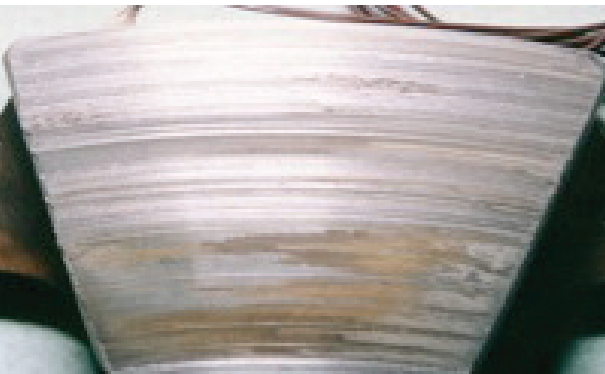
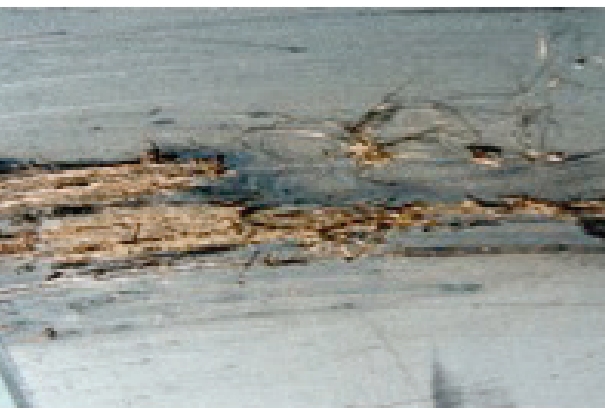
# Wire Wool Damage

- Very heavy scoring of the whitemetal surface in short time period
- Hard scabs of material embedded into the whitemetal surface

- Failure initiated by small particles of dirt embedding into the bearing surface
- Shaft material containing chromium or manganese in the region of 2% - 14% are incompatible with whitemetal
- Long term exposure to water in oil can lead to scab formation (tin oxide)
- Most aluminium bronzes are incompatible with whitemetal

- Change journal or collar material to mild steel
- Hard chrome surface in contact with whitemetal

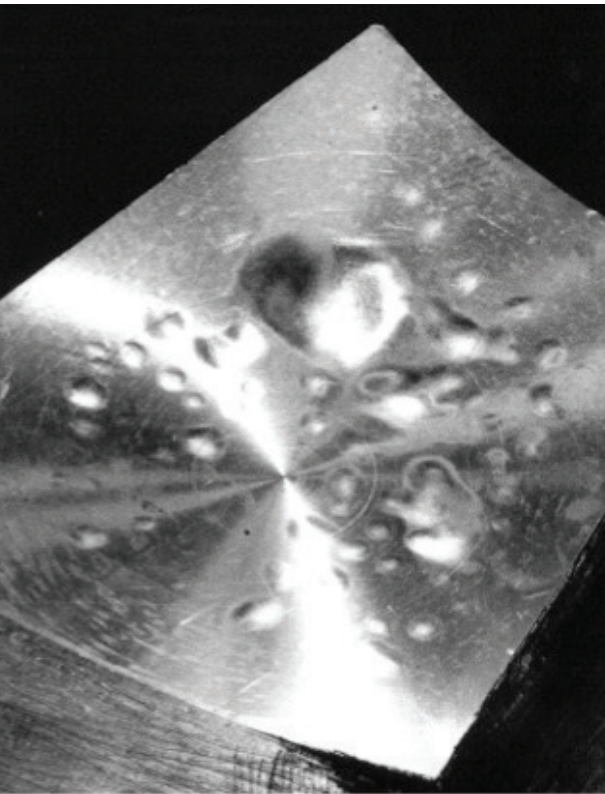
# Hydrogen Blisters

- Blister under the whitemetal layer
- Can become visible following long periods of storage or operation

- Hydrogen within the mild steel diffuses out to the bond line then becomes trapped, breaking the mechanical bond

- Degas steel prior to use through thermal or vacuum treatment
- Repair blistered surfaces
- Avoid hydrogen sources during manufacture

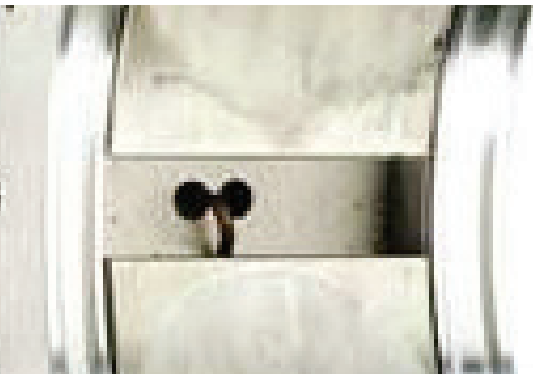
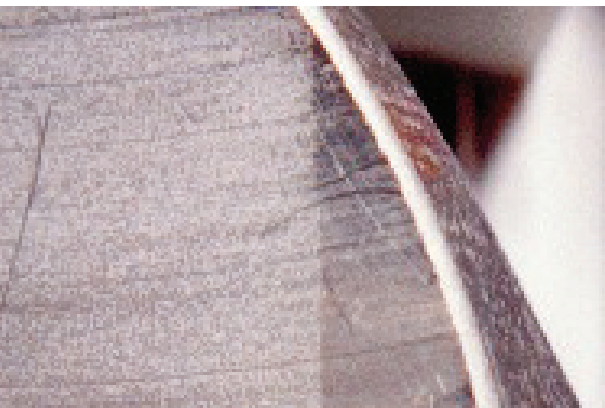
# Electrical Pitting

- Numerous uniform pits concentrated in discrete areas
- Frosted appearance in pitted area
- Pitting concentrated to areas with lowest oil film thickness (least insulation)
- Damage will be present on both the bearing and shaft

- Poor insulation allowing electrostatic arcing between the shaft and bearing
- Electromagnetic currents from rotating shaft
- Water in oil or film cavitation disrupts insulating effect of the oil

- Grounding of shaft currents
- Insulation of bearings
- Replace lubrication oil and flush housing to remove water content

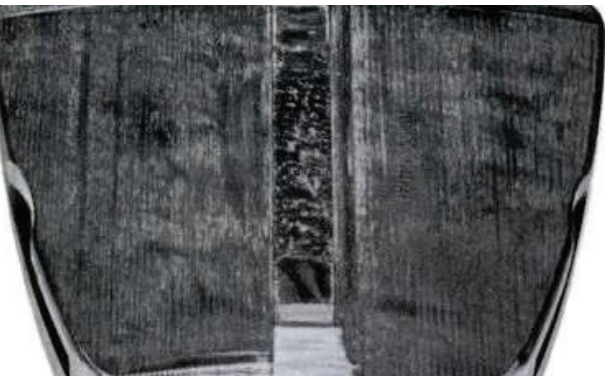
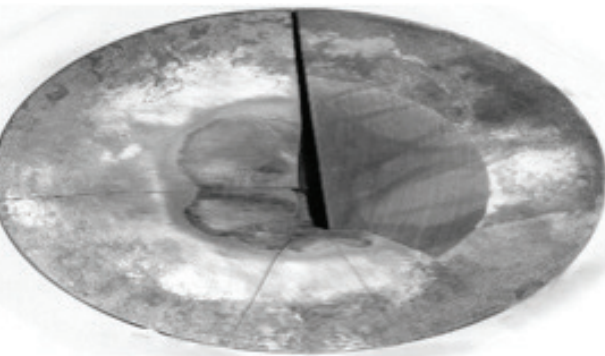
## Pivot Damage / Fretting

- Wear and erosion of contact surfaces
- Discolouration around contact area
- Cracks or fractures to highly loaded pivot point
- Flattened pivot area

- Fretting caused by vibration of machinery
- Overload of pads
- Insufficient pivot contact area to support load

- Repair existing pivots
- Reduce the load on the pivots or increase the pivot radius to support higher loads
- Minimise external vibrations
